HYDROGEOLOGICAL ASSESSMENT OF THE CLOSED COBOCONK LANDFILL

OCTOBER 1989

Report Prepared for:
Waste Management Branch

Report prepared by:
Gartner Lee Limited

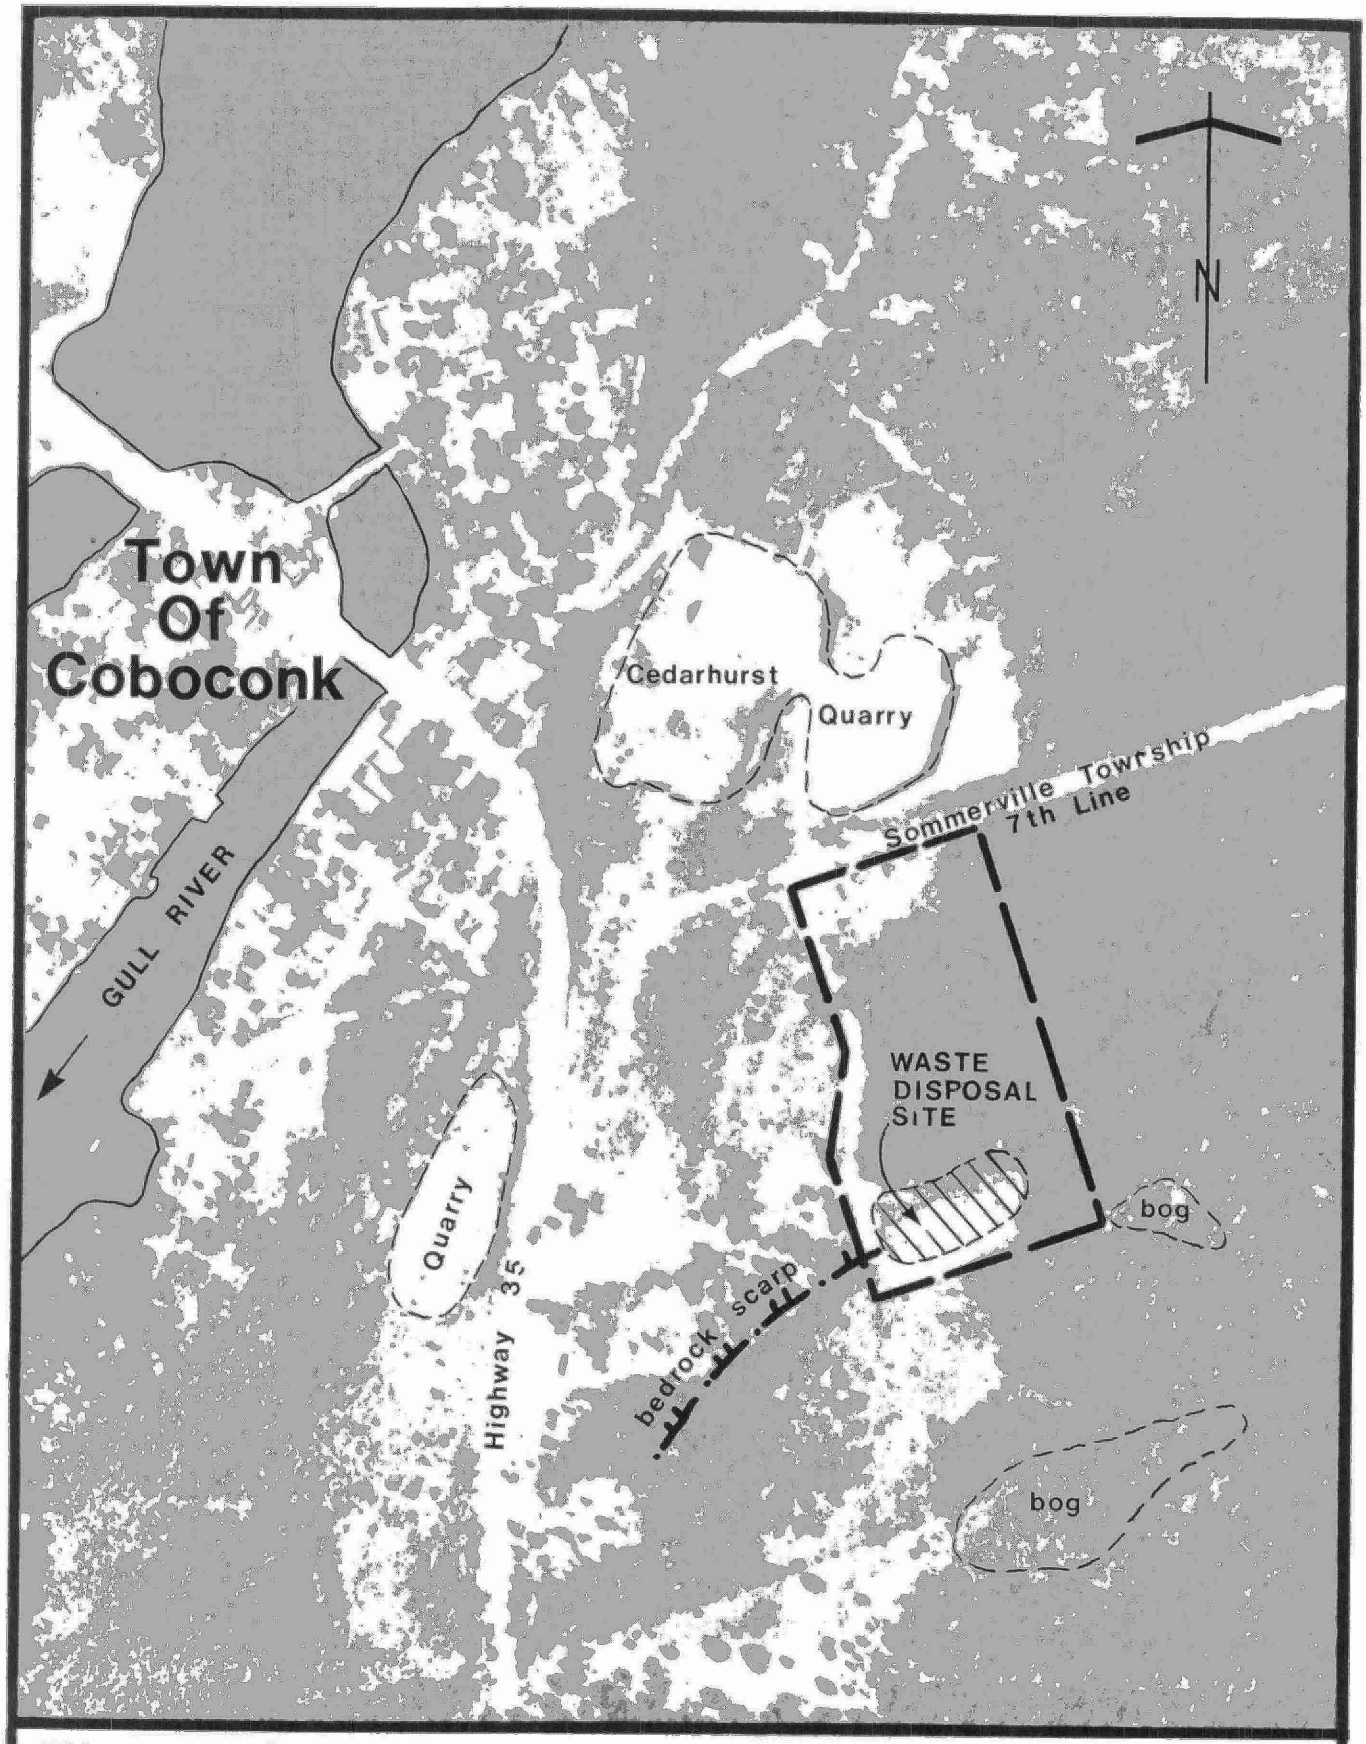
Figure 2 illustrates that the landfill was well established in 1969. Quarries are apparent to the north and west of the site and bogs or swamps are present to the south and east. A bedrock scarp is also apparent just west of the landfill. No vegetation is established on the landfill.

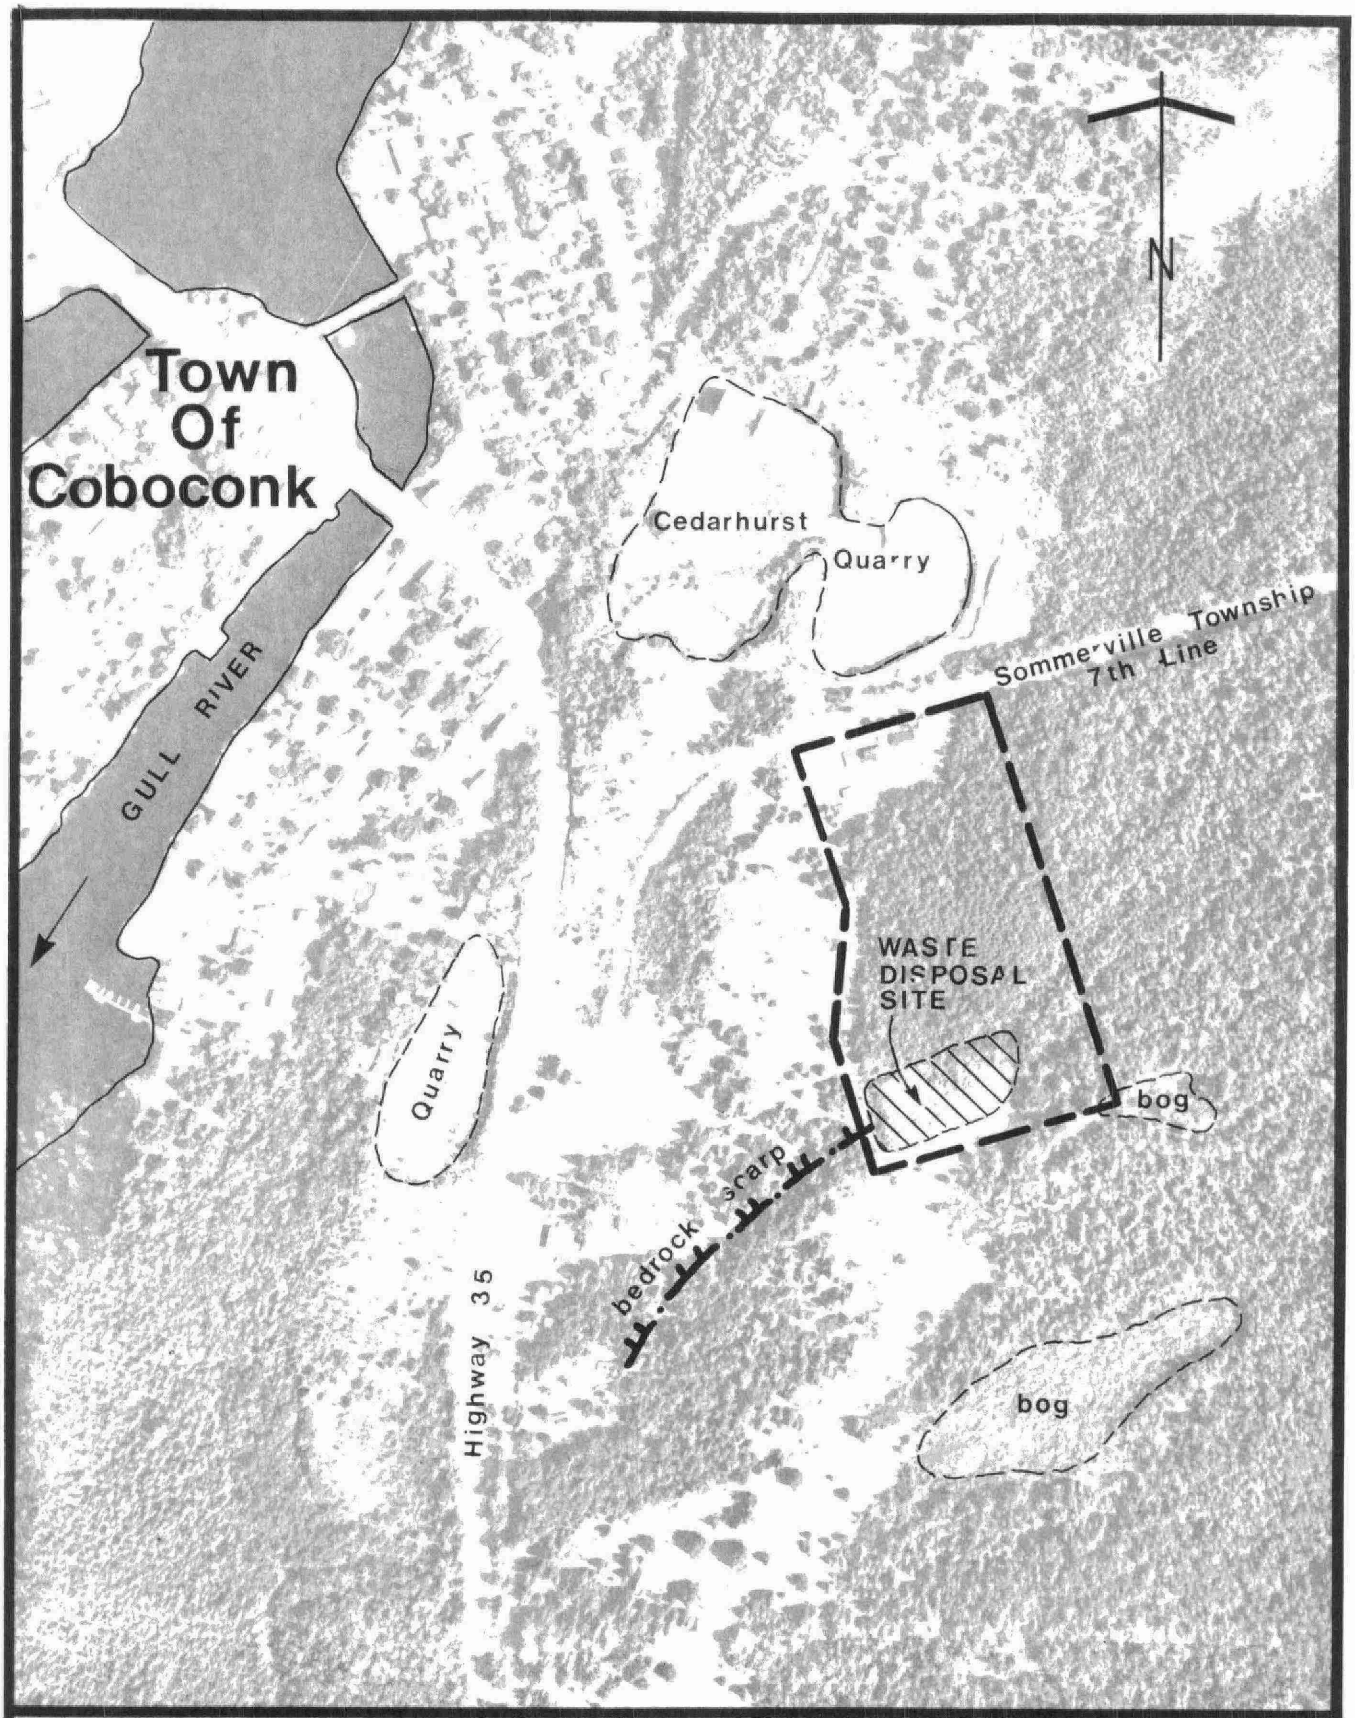
Figure 3 shows the site in 1978, four years after it closed. Some vegetation is established on the landfill but most of the area appears largely unchanged from 1969. Both quarries are unchanged which suggests they were largely inactive during this period.

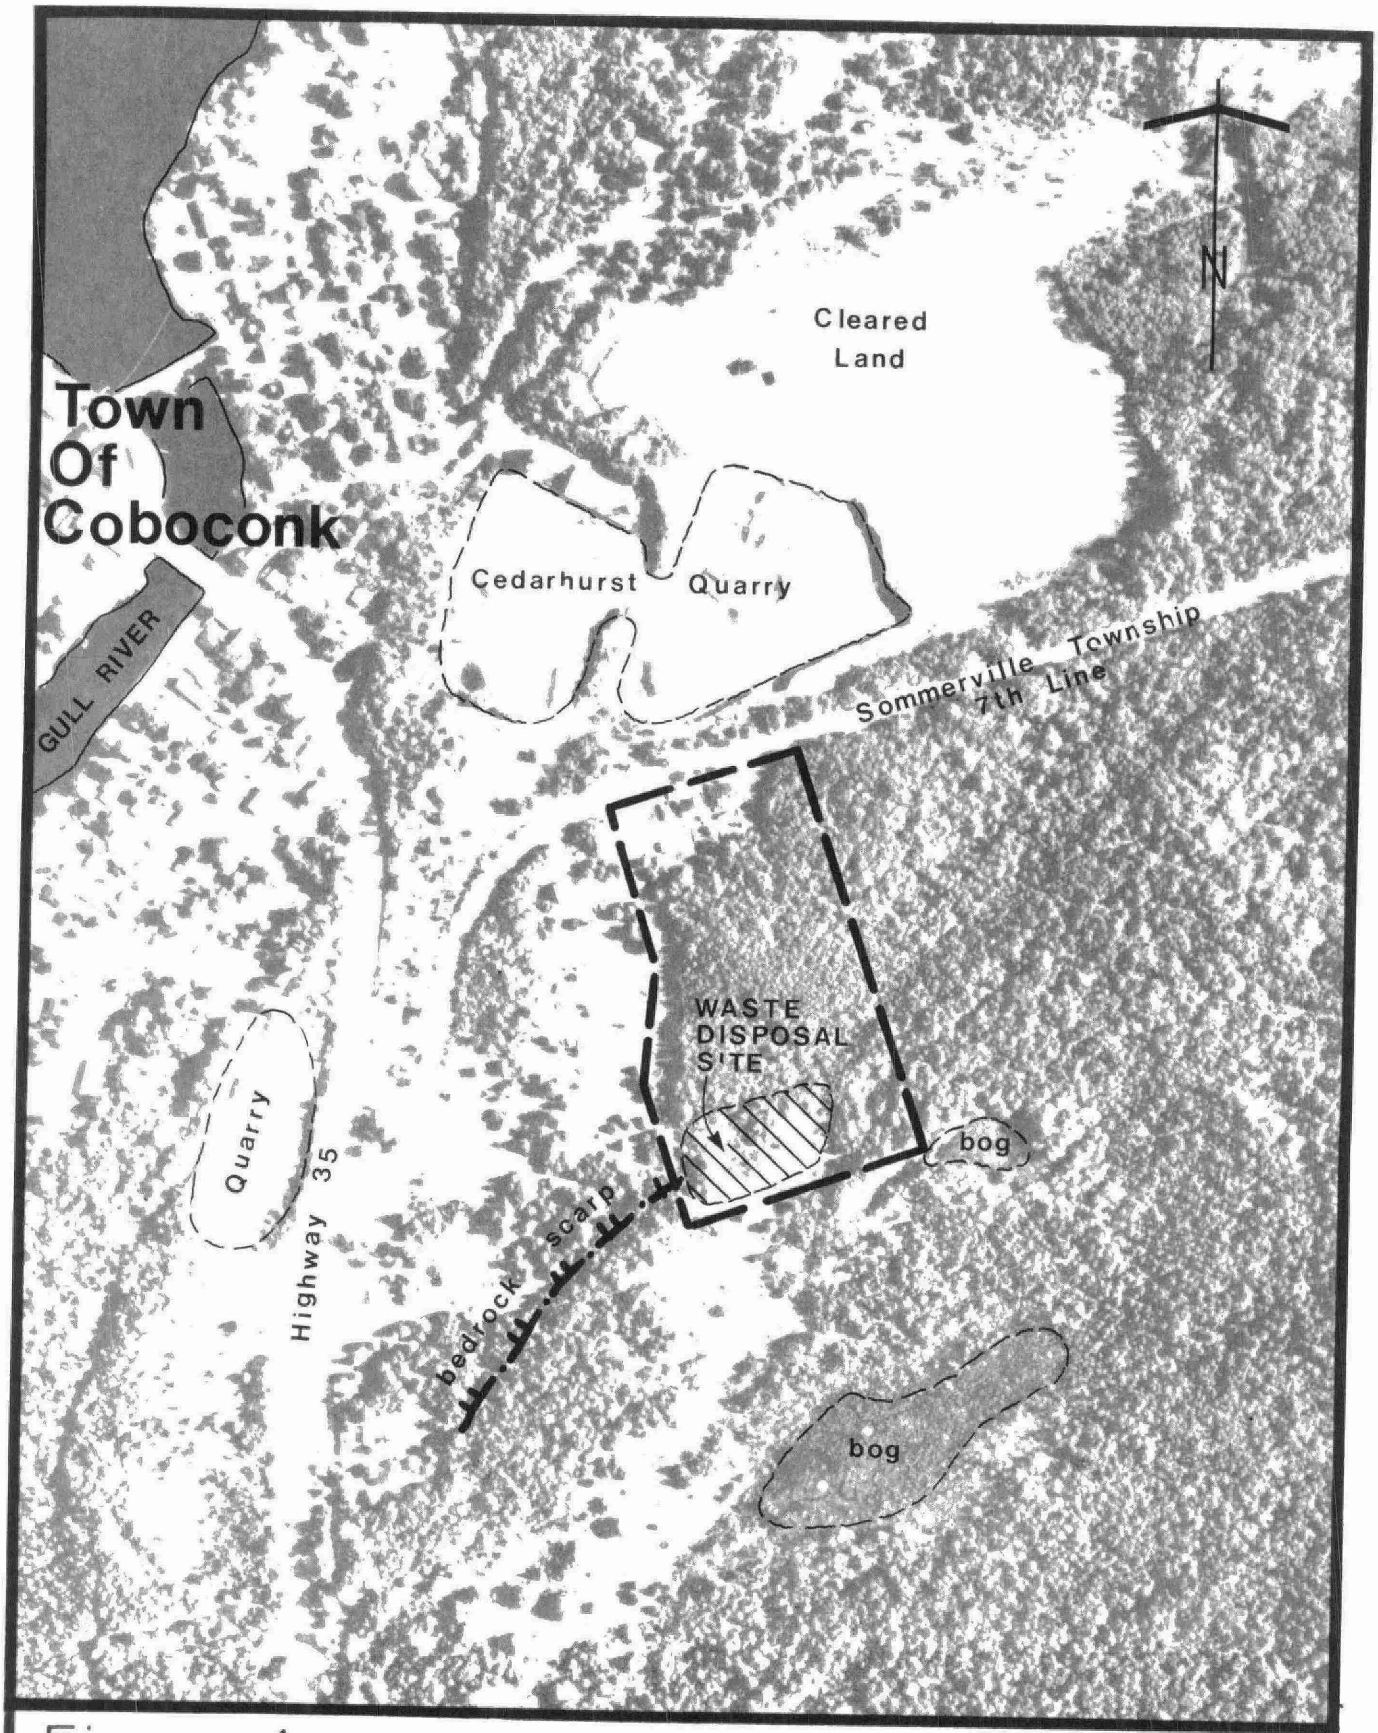
Figure 4 shows the site in 1987, thirteen years after closure. The landfill is covered with shrubs, trees and grasses. The access road into the site is partially overgrown. A new

house has been built on 7th Line Road about 180 m northwest of the landfill. Cedarhurst Quarry to the north has expanded and a large area of land has been cleared presumably for additional quarrying in the future. The quarry to the west remains unchanged from conditions in 1969.

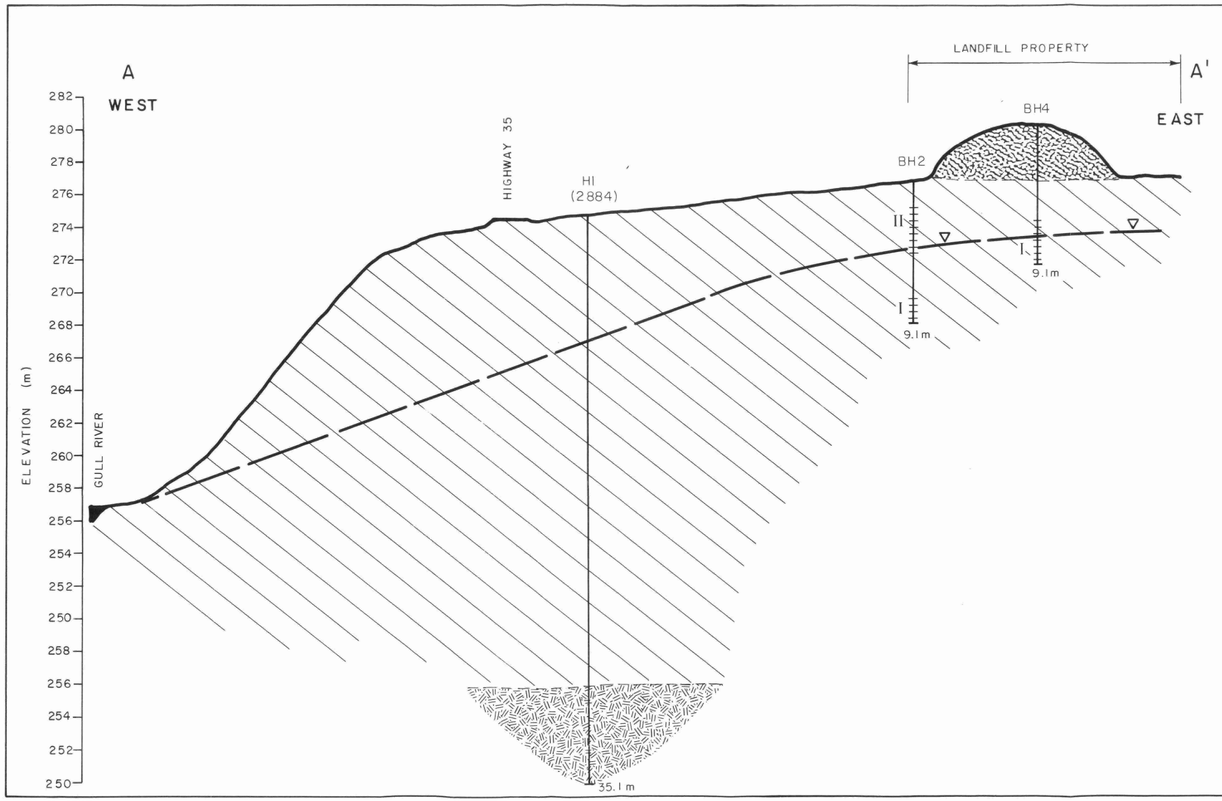
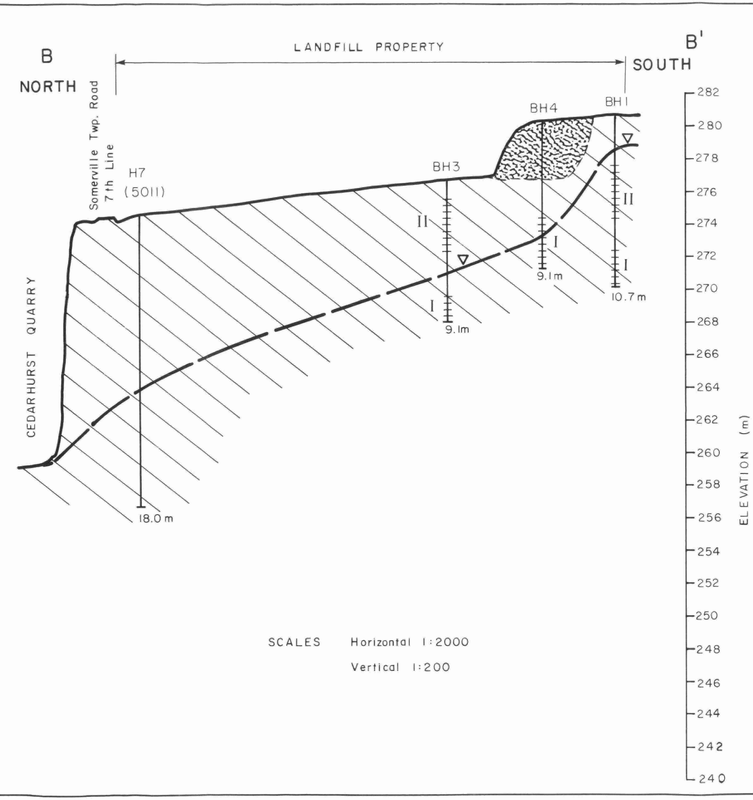
Figure 5 presents two cross-sections which illustrate how the landfill is related to the major topographic features in the area. Section A-A' runs east-west and Section B-B' runs north-south as shown on the site plan, Figure 6. Section A-A' shows how the land surface and the inferred water table slope eastward to the Gull River. Section B-B' illustrates how the grades in the Cedarhurst Limestone Quarry relate to the landfill and locally affect the water table elevation. The bedrock scarp at the south end of the landfill is also apparent on Section B-B'.

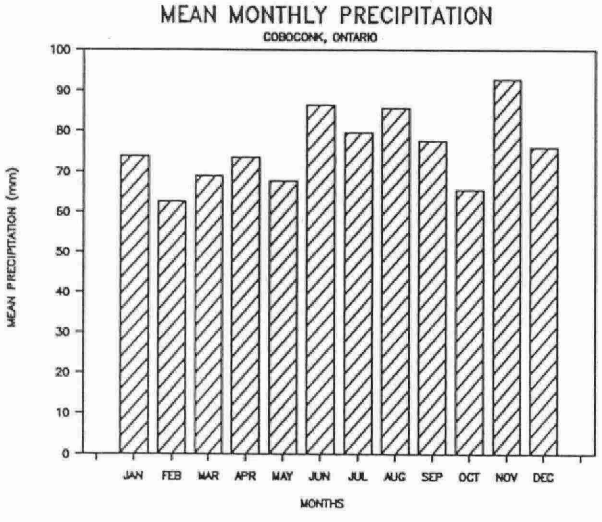
FIGURE 7

The mean annual precipitation at Coboconk is 909 mm per year, based on 11 years of meteorological data from 1970 to 1980. There is some variation, from year to year, in the total annual precipitation (standard deviation of 108 mm about the mean value). The distribution of the precipitation varies from month to month, as shown on Figure 7, for a normal year.

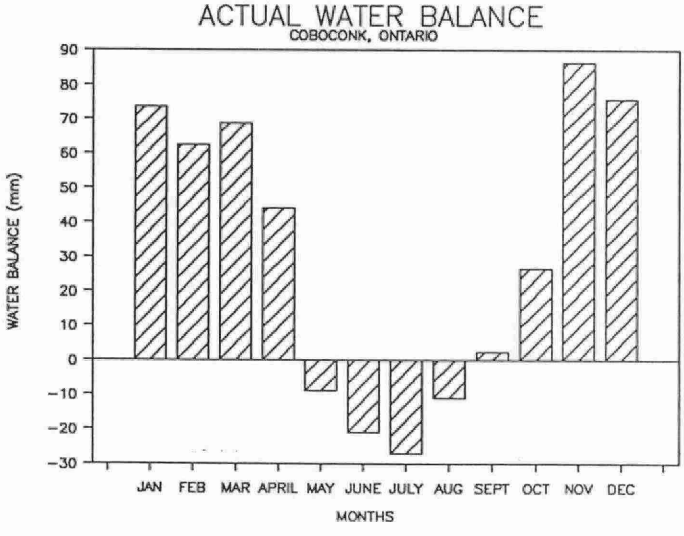
FIGURE 8

The distribution of the surplus water on a monthly basis through a normal year is shown on Figure 8. It shows that a significant surplus of 440 mm occurs during the autumn, winter and spring months and a deficit of 68 mm occurs during the summer.

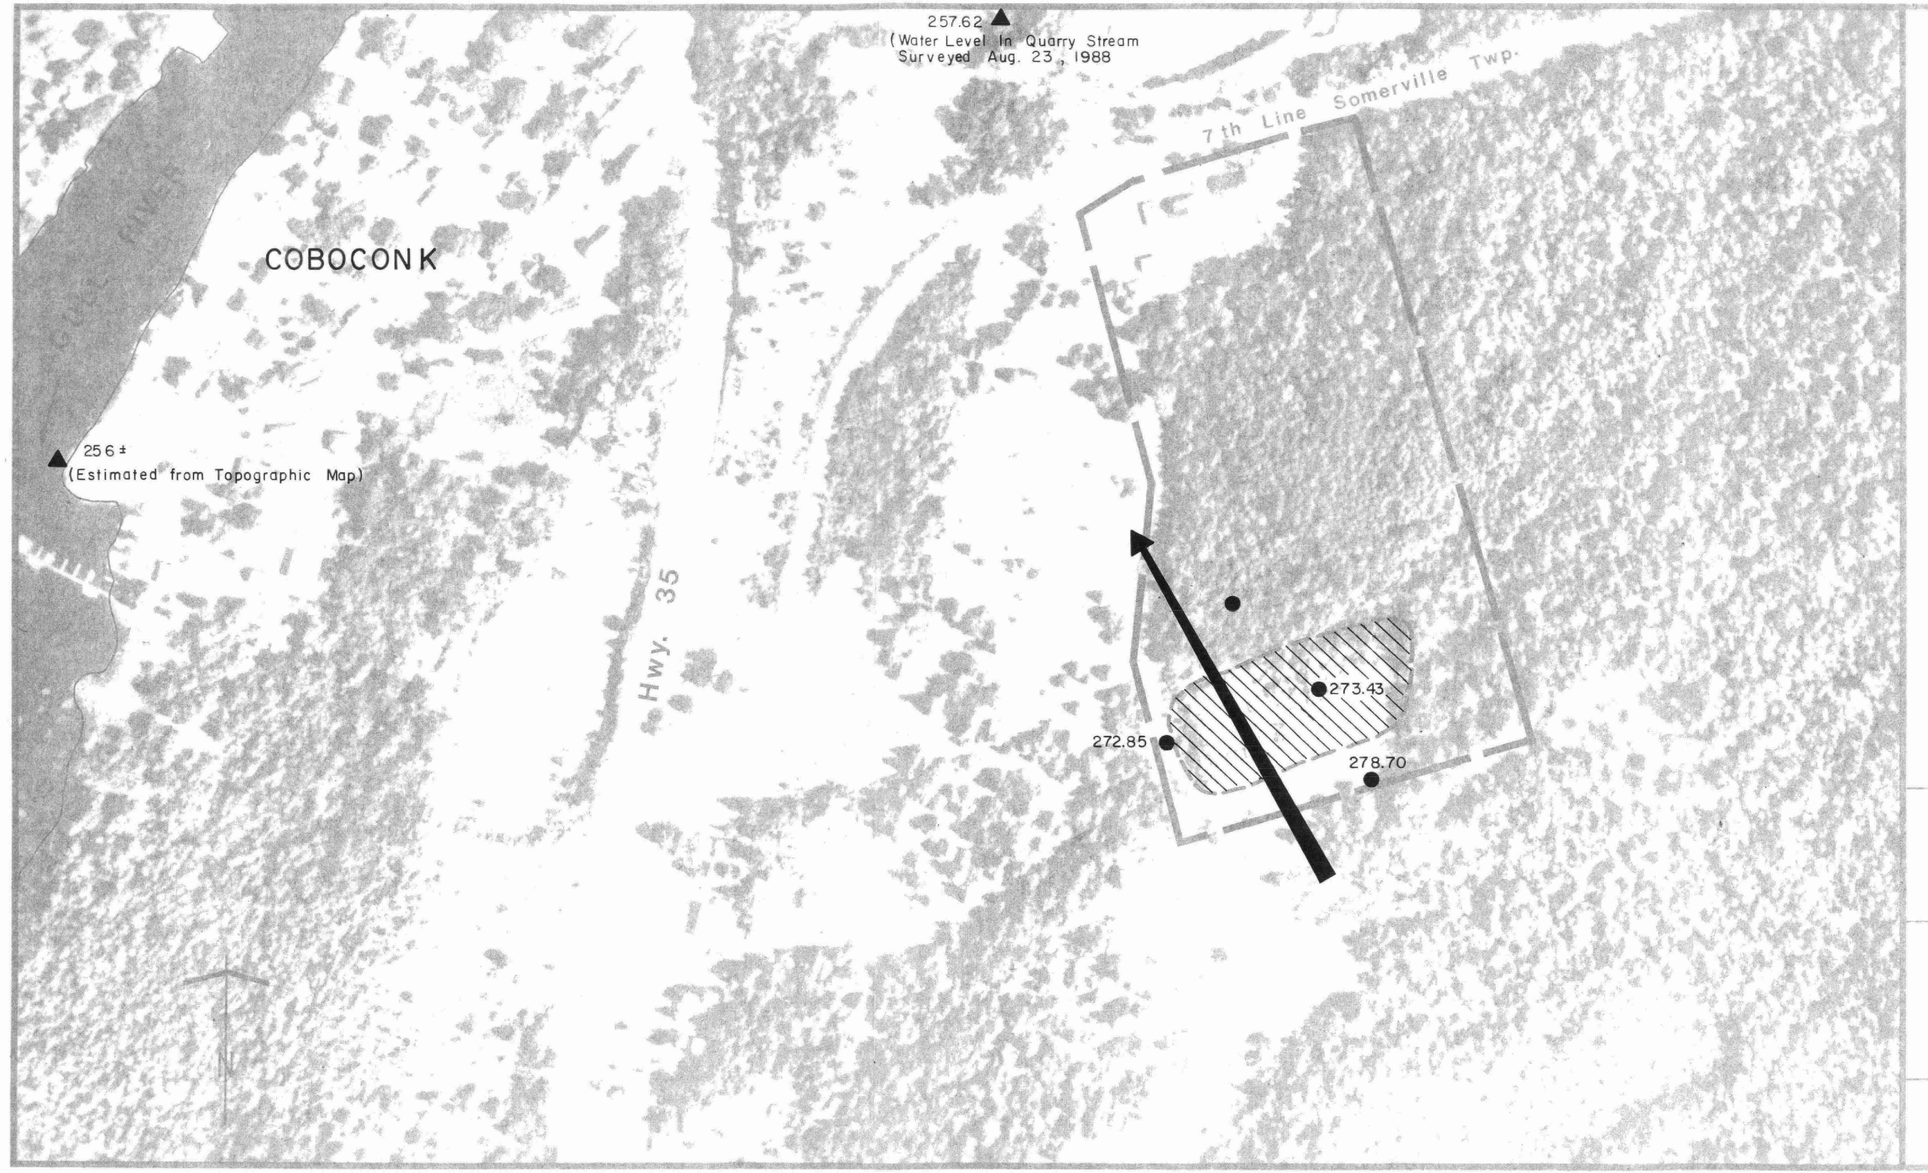
Figures 9 and 10 present water table elevation maps for August 25 and November 11, 1988 based on water level elevations in on-site ground water monitors. A surveyed water level elevation in the Cedarhurst Quarry drainage ditch and an estimated water level for the Gull River (estimated from 1:50,000 topographic map) are also provided on Figures 9 and 10 to illustrate how ground water elevations at the landfill site relate to the regional ground water flow system.
